RCRA INSPECTION REPORT

Facility Name: File: G-02-02-004
Jard Company Incorporated
Bowen Road
Bennington, VT 05201
(802) 442-3173

Type of Inspection: Initial

Date of Inspection: September 20, 1989

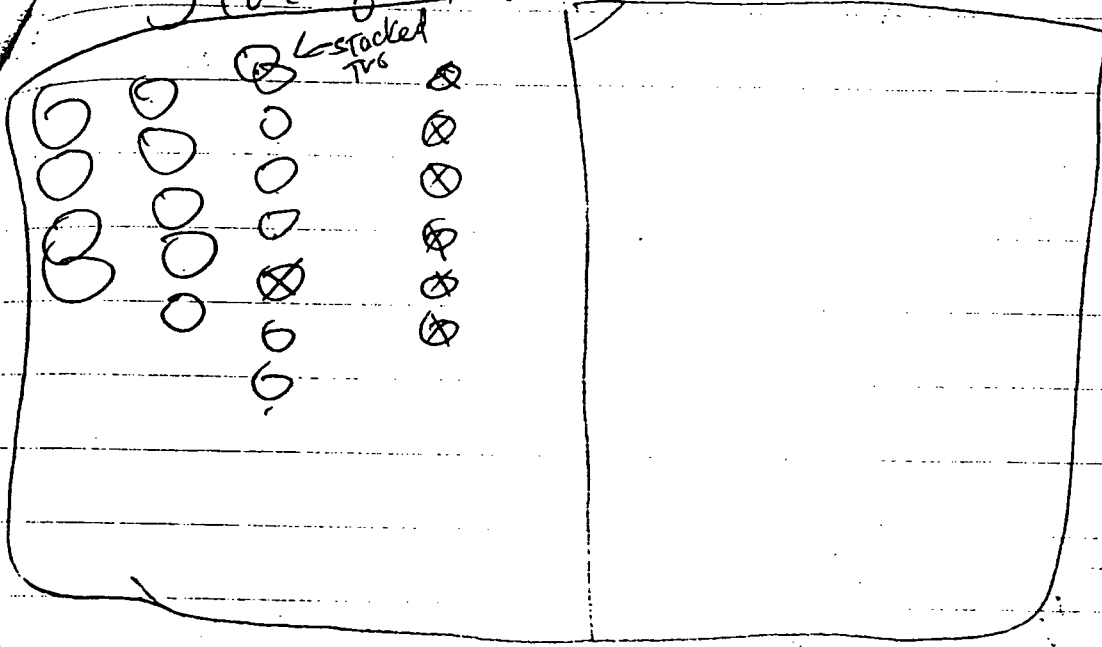
Storage Diagram

7 Fiber drums <
15 55 gallon
1 ~30 gallon corrosive label

~ 35 55 gallon steel
~ 30-40 5, 10 gal assorted other size
